TCS-80772/65 June 1965

PHOTOGRAPHIC INTERPRETATION REPORT

SELECTED RADAR TRACKING FACILITIES, KY/VMTC AND GULF OF FINLAND AREAS, USSR

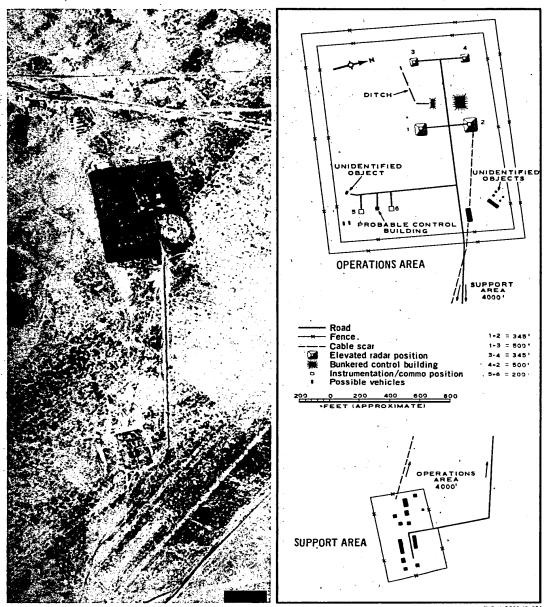
FIGURE 4. ELTON RADAR TRACKING FACILITY.

Mounds/Radars: 4 mounds (items 1-4) appear unoccupied, and no radars are visible within the facility

Instrumentation/Communications Positions: 2 unoccupied hardstands (items 5 and 6) with a small probable control building between them

Control Buildings/Revetments: No revetments, but 1 large and 1 small bunkered control building are situated between the mounds Support Area: Secured area with 12 buildings

situated 4,000 feet east.

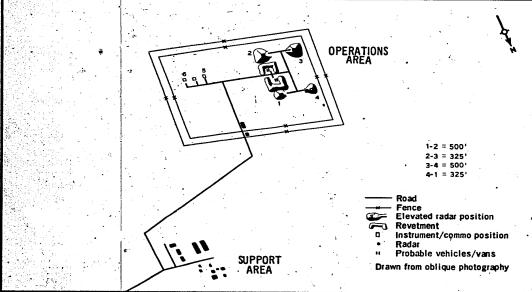
FIGURE 5. GORNYY BALYKLEY RADAR TRACKING FACILITY.

Mounds/Radars: 4 mounds (items 1-4), the first 3 of which are occupied by radars of unidentified type

Instrumentation/Communications Positions: 2 of 3 positions (items 5 and 6) appear occupied

Control Buildings/Revetments: 2 C-shaped revetments between mounds 1 and 2 appear occupied by probable vehicles/vans; no control buildings could be identified Support Area: An unsecured area of at least 13 buildings is 2,000 feet to the northeast

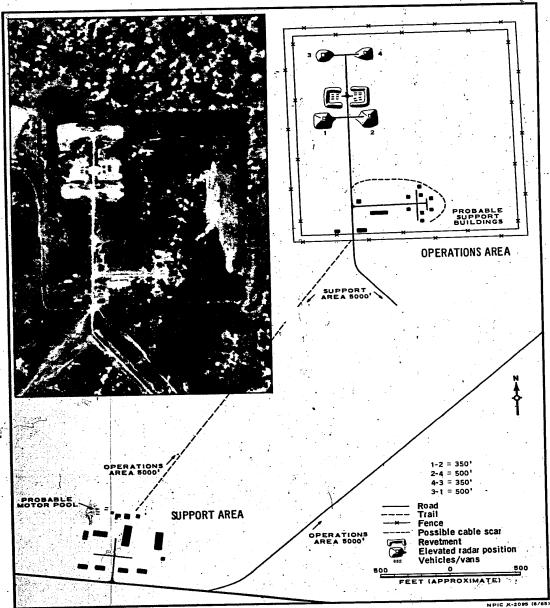
FIGURE 6. PALLASOVKA RADAR TRACKING FACILITY.

Mounds/Radars: 4 mounds (items 1-4) appear unoccupied, and no radars are visible within the facility

None identified

Control Buildings/Revetments: 2 C-shaped revetments contain 4 rows of vehicles/vans; no control buildings could be identified Support Area: A possible cable scar leads 5,000 feet southwest to an unsecured area containing at least 13 buildings

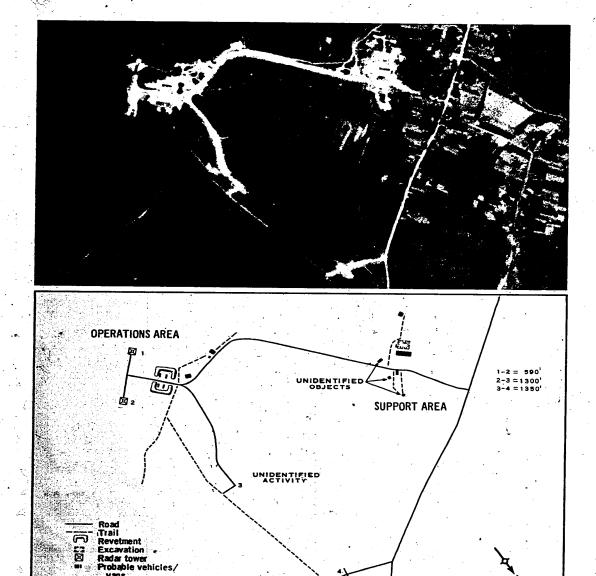
FIGURE 7. NARVA RADAR TRACKING FACILITY.

Towers/Radars: 2 towers (items 1 and 2)
are apparently occupied but radar type
remains undetermined because of smallscale photography

None identified

Control Buildings/Revetments: 2 C-shaped revetments contain probable vehicles/vans; no control buildings could be identified Support Area: A small unsecured area 2,000 feet west-northwest contains at least 3 buildings, 3 unidentified objects, and several probable vehicles/vans

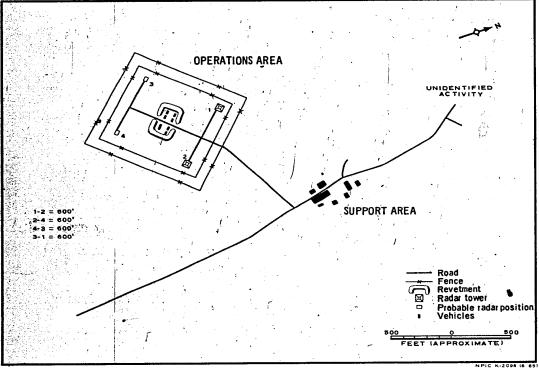
FIGURE 9. VESKITAGUSE RADAR TRACKING FACILITY.

Towers/Radars: 2 radar towers (items 1 and 2) and 2 probable radar positions (items 3 and 4) are visible, but it cannot be determined what radars, if any, are present

Instrumentation/Communications Positions: None identified

Control Buildings/Revetments: 2 C-shaped revetments contain vehicles, but no control buildings are present

Support Area: Unsecured area about 1,100 feet northeast contains approximately 8 buildings

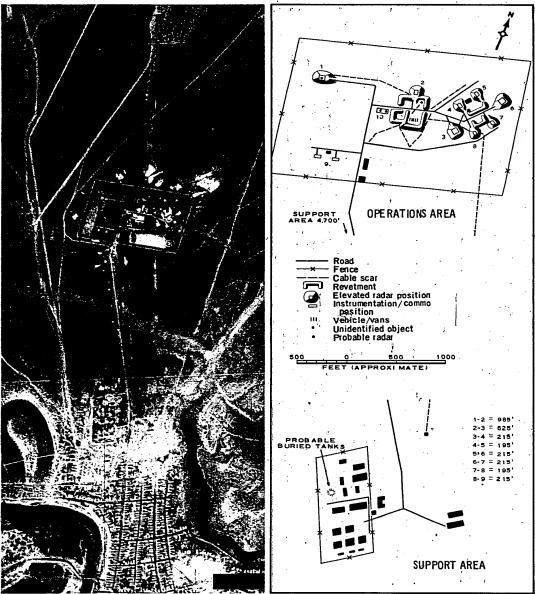
FIGURE 11. ALEKSANDROV GAY RADAR TRACKING FACILITY.

Mounds/Radars: Of 8 mounds (items 1-8), at least mound 1 is occupied by a probable

Positions occur at items 9 and 10, but precise occupancy cannot be determined

Control Buildings/Revetments: Single control building situated between mounds 4 and 5; 5 revetments, at least 2 occupied by either vehicles/vans or unidentified objects

Support Area: Secured area about 4,700 feet south-southeast contains at least 16 buildings including 5 barracks, several administration types, and other maintenance/utility types; a cable leads to the operations area
